# St Nicholas Church, Worth

### **Concept Design Document**

February 2019

#### **COWAN ARCHITECTS LTD**

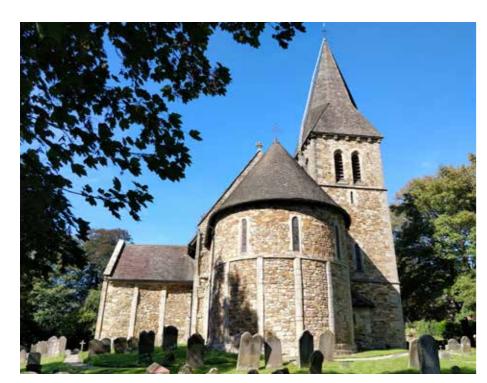
Fig 2: East end of St Nicholas, showing apsidal chancel in foreground.

It is notable for being the only Saxon cruciform church with an apsidal chancel which is complete in plan form. It has a wide high nave, low transepts and a lower chancel. It is constructed of Wealden Sandstone with a red clay tiled roof generally. There is a tower to the north-east (added in 1871 and replacing an earlier timber structure, there is an indication of this in the background of Fig 3, to the right of this page) with a cedar shingled broach spire. A major scheme of restoration and alteration was carried out in 1986 following a fire which destroyed the roof. At this time the floor and seating were replaced internally.

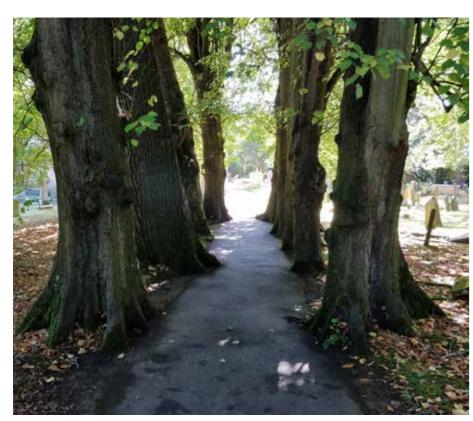
Fig 4: Photograph of access pathway from lychgate to church, taken in Summer 2018.

The pathway was resurfaced four years ago in an attempt to improve access along it, though root damage from the trees has had a significant effect on the usability of the pathway since then. The churchwardens have noted that with an elderly congregation, members of the local community have been forced to move to other local churches due to the inaccessibility of the pathway surface for wheelchair users and ambulant disabled members. They also report access issues for funeral pallbearers and wedding parties.

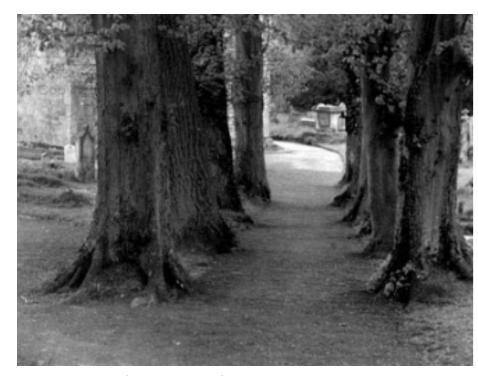
Fig 5: Photograph of access pathway from lychgate to church, taken in 1955 showing the more generous pathway width in the mid-20th Century (Francis Frith).

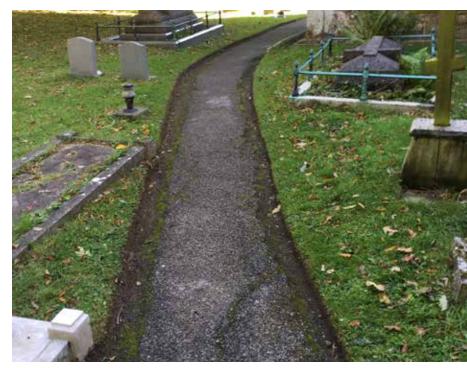
Fig 8: Photograph of a section of cracked tarmac pathway around the periphery of the church.

- Assess the surface treatment of the wider pathways of the churchyard. The immediate proposals are to improve or alter the entrance route to the church, however the other pathways which encompass the church building and run to the former rectory to the south would also benefit from a change to their surface finish. The current tarmac surface has been noted to be a slip hazard in frosty, wet or autumnal conditions, it is cracked in places and drains poorly.

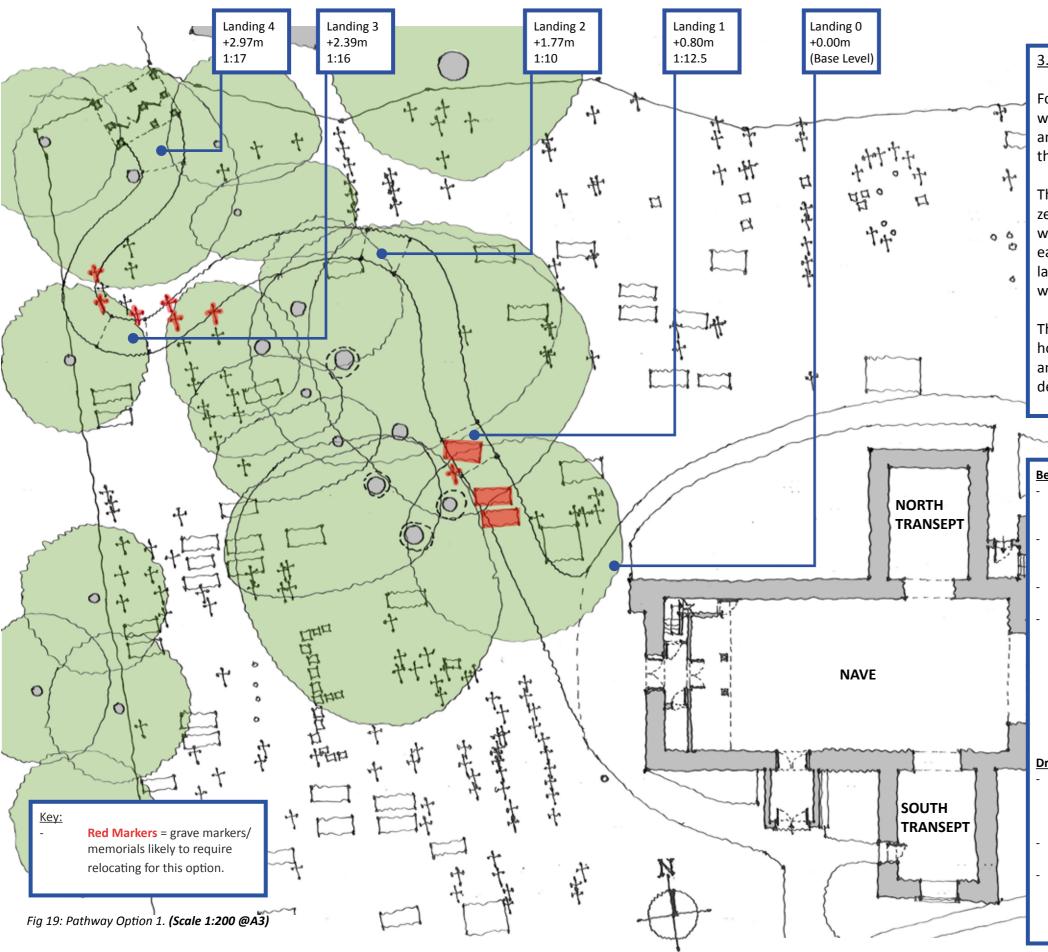
#### 3.3 - Pathway Option 1

For Option 1, we aimed to introduce a ramped entrance pathway which adhered as closely as possible (within the physical restrictions and existing level change of the site) to the recommendations of the Part M Approved Document.

The notes to Figure 19 indicate the level change from a datum of zero around the west entrance to the church (up to the dashed line where the pathway slope would begin), with the level change of each landing, and the associated pathway incline ratio up to the landing. The distance between each landing is 10 metres, and the width of the pathway is 2 metres.

- A number of graves would have to be relocated. Those highlighted in red on the option drawing of Figure 19 are those marked on the site survey, though this should be viewed as the minimum – other vaults or unmarked adjacent graves could also be affected by the works.
- The pathway, though shallower than the current entrance path, still does not comply with building regulations.
- The route does not align with the presumed historic route between the lychgate and church. The avenue of trees is presumed to have referenced the location of a pre-existing route, and with the loss of this route the avenue is felt to be somewhat negated.

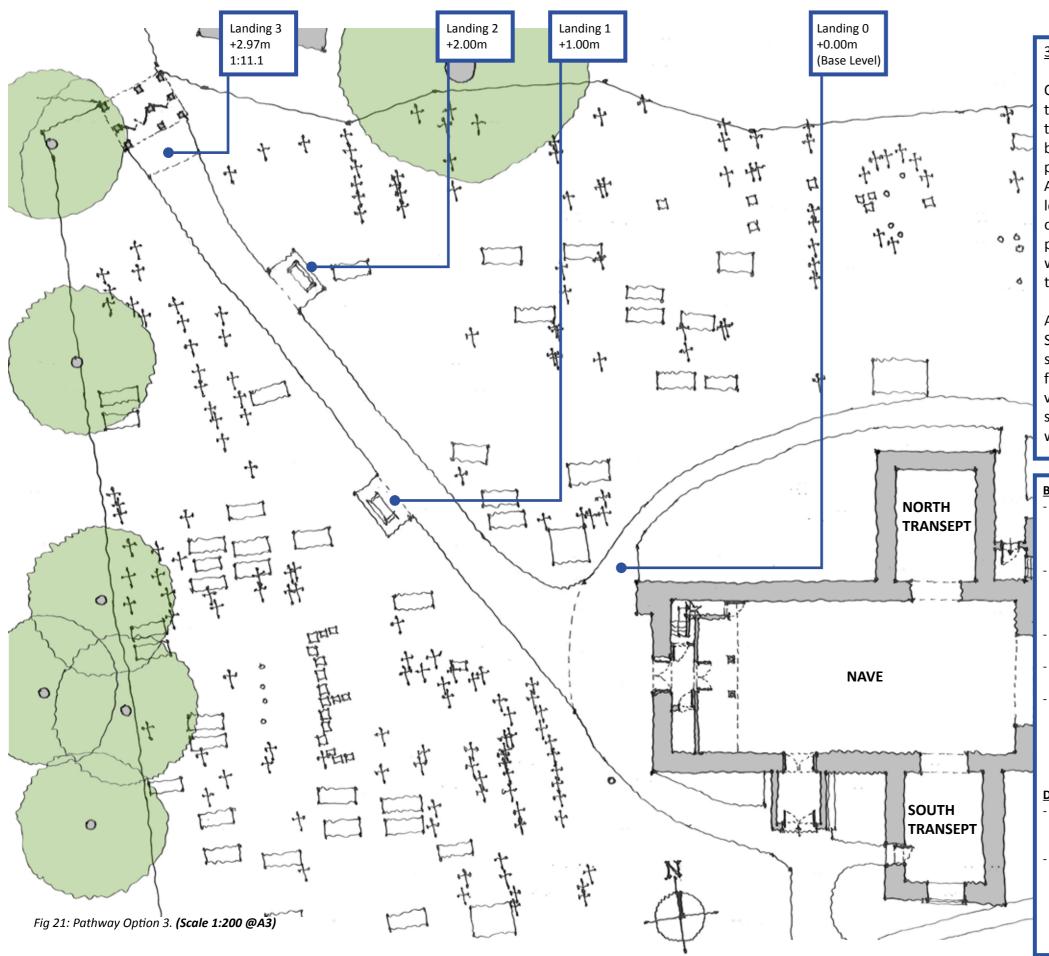
#### 3.5 - Pathway Option 3

Option 3 looks at retaining the existing access route, starting at the lychgate and taking the most direct route to the west end of the church. It proposes the removal of the avenue of trees (to be replaced with new trees in a more sensitive location in the proposed Memorial Garden to the south-east of the churchyard). As the starting and ending point of the pathway as well as the level change between the two are set out by the existing site, this option attempts to improve the accessibility of a new pathway by providing resting points along the route rather than landings, which would necessitate increasing the incline of the graded sections of the pathway.

- No graves are envisaged to requiring relocating, unless one were found under the current pathway, though this is considered unlikely due to the ground already having been disturbed and closely bounded by the current avenue of tree routes below ground.

- The avenue of trees would be removed as part of these proposals, and though they are noted to cause several issue to accessibility to the site, their loss is still a drawback of this option.
- The pathway, though shallower than the current entrance path, still does not comply with building regulations. It is hoped however that by not having landings along the pathway, instead having two to either side at circa 10 metre intervals, the gradient would be 1:11.2, which is better than that proposed in Option 2 where landings are included along the route at 10 metre intervals.

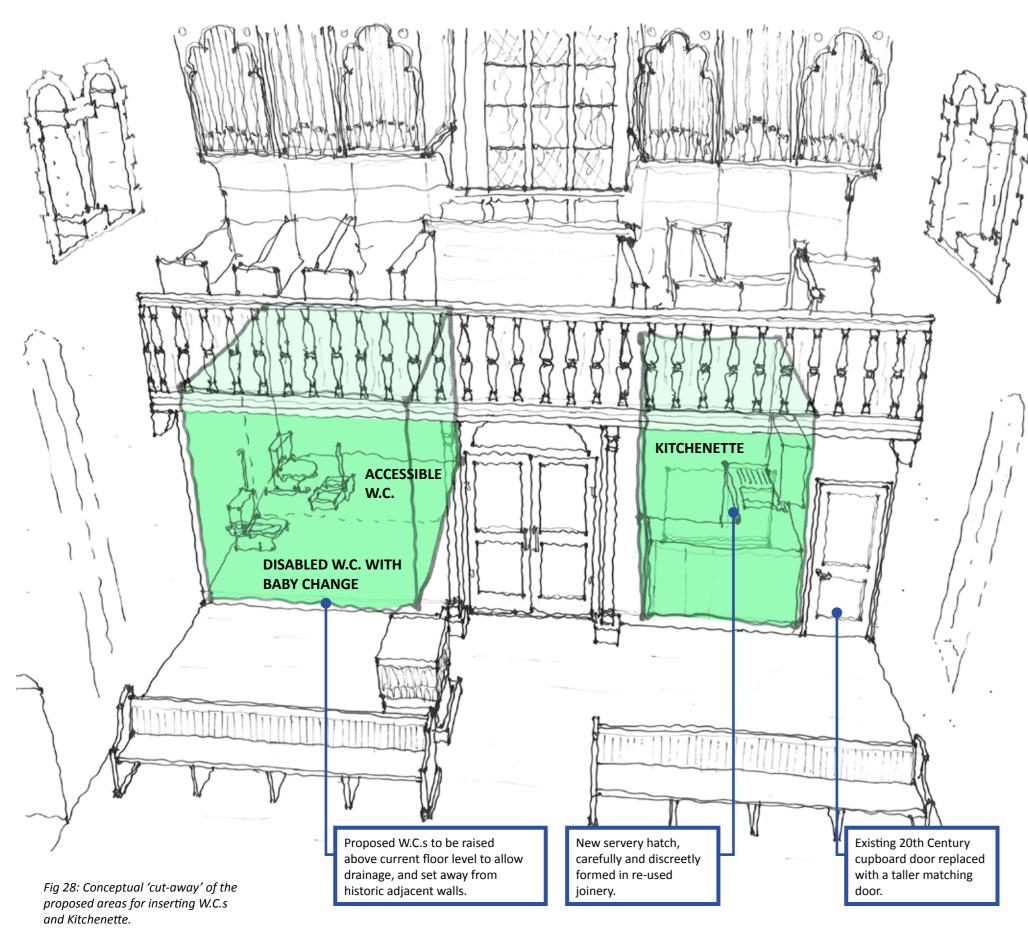
#### 4.4 – Considering the Impact on the Interior of the Church

As noted previously, the proposals would re-use the existing panelling, double doors and over-light of the good quality 20th Century joinery. The door to the enlarged storage cupboard might be replaced to be taller and therefore more accessible for servicing the organ blower, electrical distribution board and sound system, and a servery hatch would be incorporated into the re-used panelling.

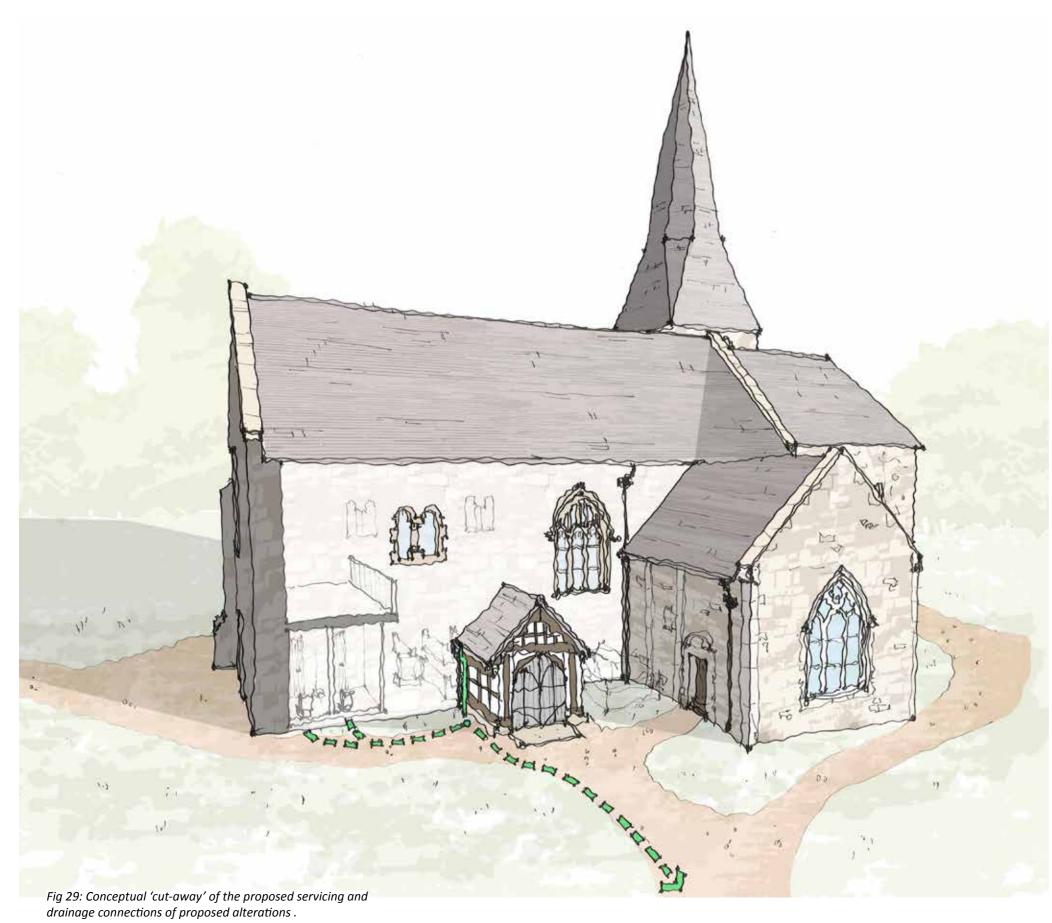
#### 4.5 – Considering the Impact on the Exterior of the Church

The proposals have been carefully designed to have a minimal impact on the exterior of the church building. The two W.C.s and kitchenette would require adequate drainage, and a connection point has been identified by the P.C.C., to a neighbouring property to the south (this is indicated by the route of the green dashed arrow in Figure 29). The W.C.s would require venting, and after considering several options for the potential location of a soil vent pipe (to cause minimal visual and historic built fabric impact), it is proposed that the most appropriate location would be adjacent to the rainwater downpipe to the west side of the Victorian south porch. This SVP is shown indicatively in green, and explored in more detail overleaf.

It is proposed that a macerator would serve each of the W.C.s and the kitchenette (to prevent all of the facilities being out of use at once should a macerator fail or block), and these would be connected to the external foul drain below ground under the existing south wall of the nave, running the foul drain under the pathway if it was to be replaced, and in the soft adjacent to it if not. It is hoped that by keeping drainage runs below or adjacent to historic pathway routes, the likelihood of discovering below ground archaeological remains would be minimal.

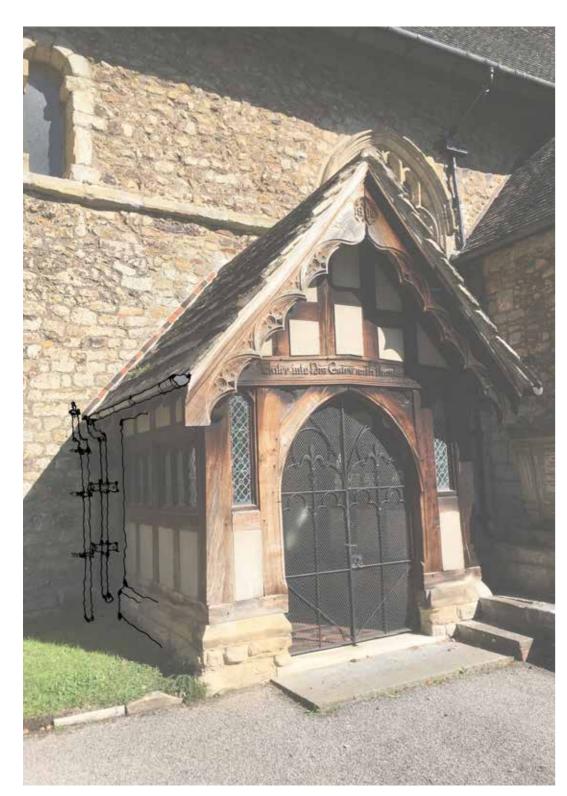
Fig 30: Proposed soil vent pipe serving macerator. Proposed to be discreetly mounted adjacent to existing rainwater downpipe.

In order to ensure that the new soil vent pipe is as discrete as possible, it is proposed that it is fitted adjacent to the existing rainwater gutter of the south porch, as shown as a sketch overlay in Figure 30. The SVP would be cast iron, as shown in Figures 31 and 32, and painted to match the existing adjacent ironwork. The holderbats which support the SVP would be fitted into the bed joints of the nave wall masonry, with stainless steel fixings to prevent damage to the mortar or stonework. This would allow the SVP to be removed and the joints repointed in the future, without damaging the surrounding stone.

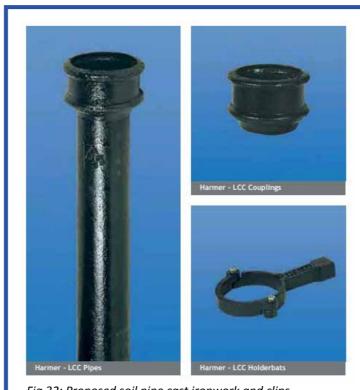
Fig 32: Proposed soil pipe cast ironwork and clips. Holderbats to be fitted into bed joints of masonry pointing to allow the intervention to be reversed in the future if necessary.

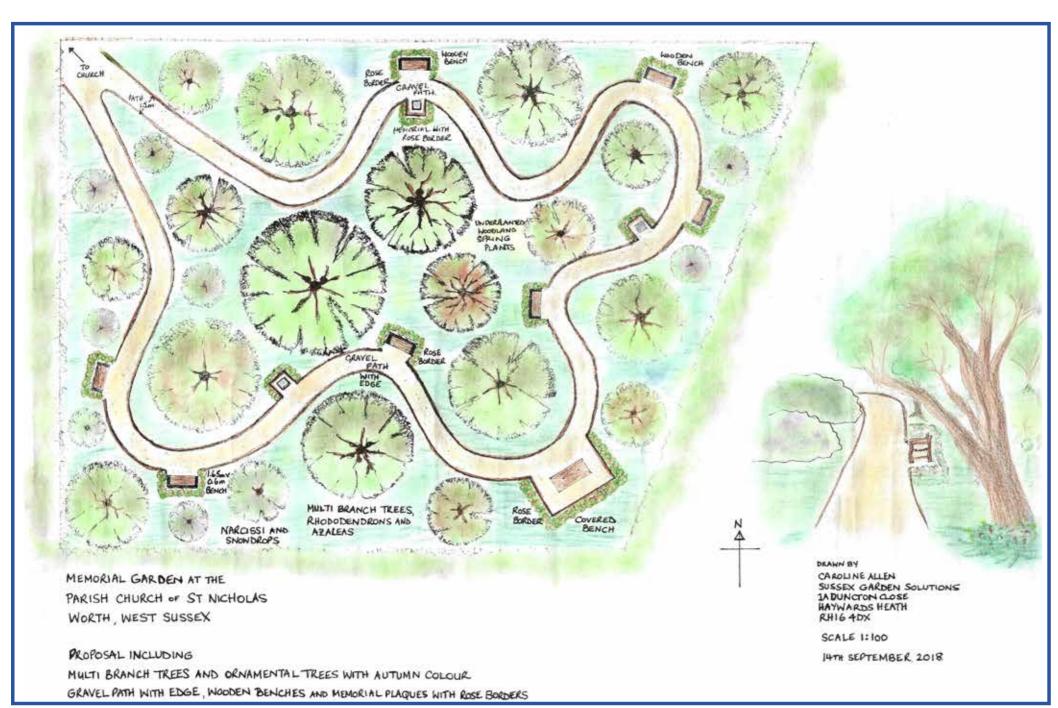
Fig 33: Proposed Memorial Garden design, prepared by Caroline Allen of Sussex Garden Solutions

The P.C.C. seeks to form a Memorial Garden to the south-east of the current churchyard, on an un-used area of land. The proposal would consist of a resin bound gravel pathway to match that proposed across the rest of the churchyard, laid out and connected as indicated in Figure 33.

The area is currently laid to lawns, the garden would introduce planting of an appropriate scale and type, as indicated in the drawing.

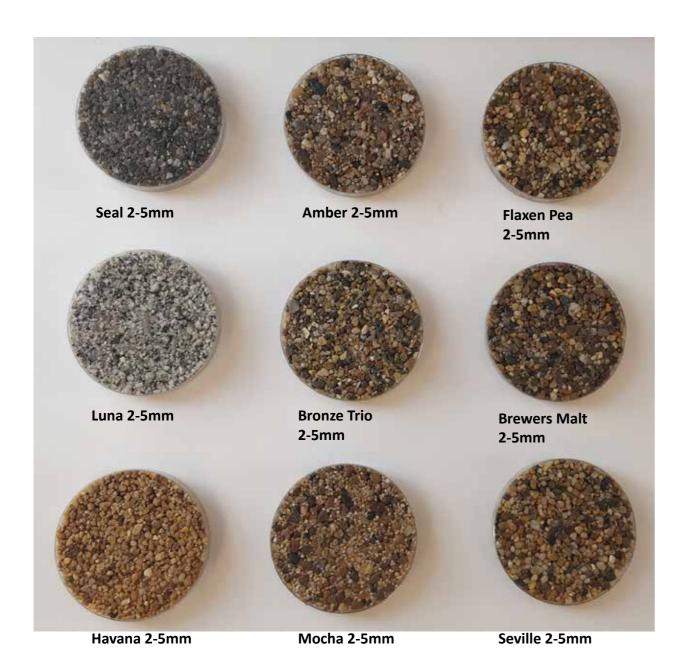
Fig \*\*: Sample resin bound gravel samples provided by Clearstone Paving of Hassocks, West Sussex.

As noted in Section 3.2, a resin bound gravel surface is proposed for the new entrance pathway of St Nicholas Church. As part of the P.C.C.s longer term ambitions, they would like to extend this surface treatment to the wider network of pathways surrounding the churchyard, eventually connecting to the proposed Memorial Garden to the South-East corner of the site.
